FLIGHT SERVICE EVALUATION
OF KEVLAR-49/EPOXY COMPOSITE
PANELS IN WIDE-BODIED COMMERCIAL
TRANSPORT AIRCRAFT

SECOND ANNUAL
FLIGHT SERVICE EVALUATION REPORT
BY
R. H. STONE

EASTERN AIR LINES AIRCRAFT N314EA
APRIL 1975

AIR CANADA AIRCRAFT CF-TNB-502
MAY 1975

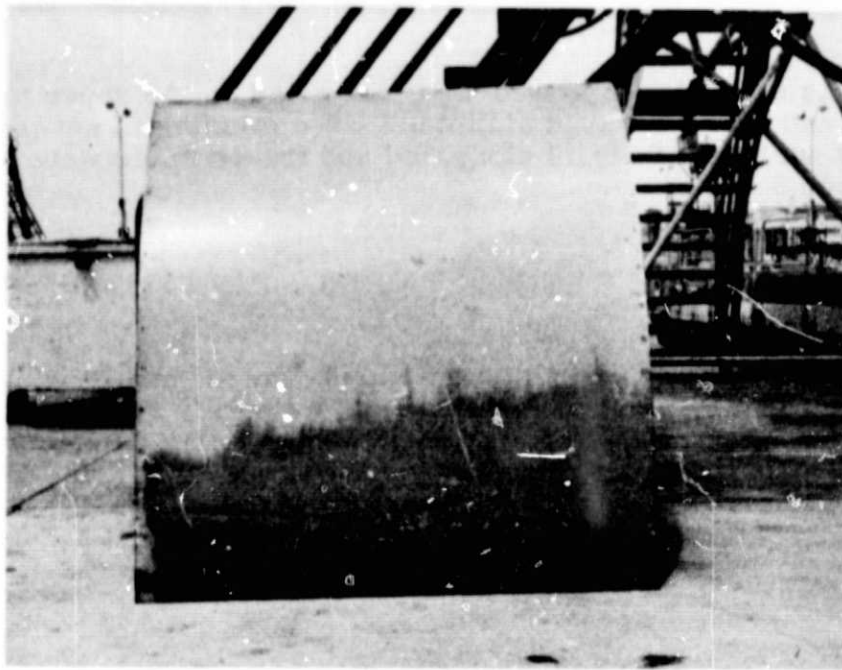
This panel was removed from the aircraft for detailed inspection. The lower half of the panel exterior was covered with a layer of dirt and grime and streaks of black, gummy deposits as shown in Figure 1. The gummy deposit appears to be rubber which blows back onto the exterior fairing surface. These deposits are typical of all lower exterior fairing surfaces. Paint chipping was noted around many fasteners and particularly along the aft edge of the panel as shown in Figure 2. Also, gap sealant adhering to the panel on the upper aft corner caused the paint to peel when the sealant and panel were moved. The flame sprayed aluminum was intact over the entire panel.

Figure 1. - Eastern LH Wing-Body Fairing -
Exterior surface

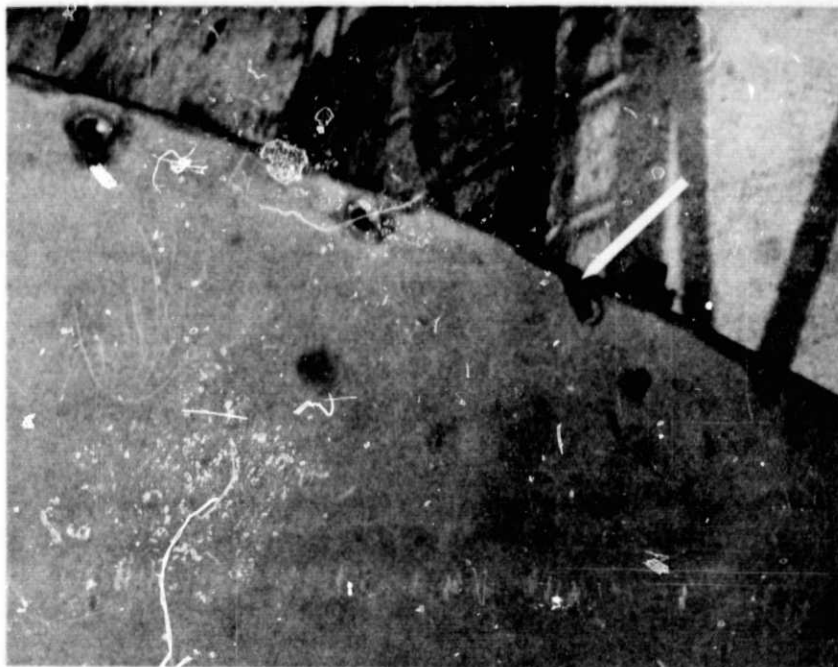
Figure 2. - Eastern LH Wing-Body Fairing -
with chipped paint

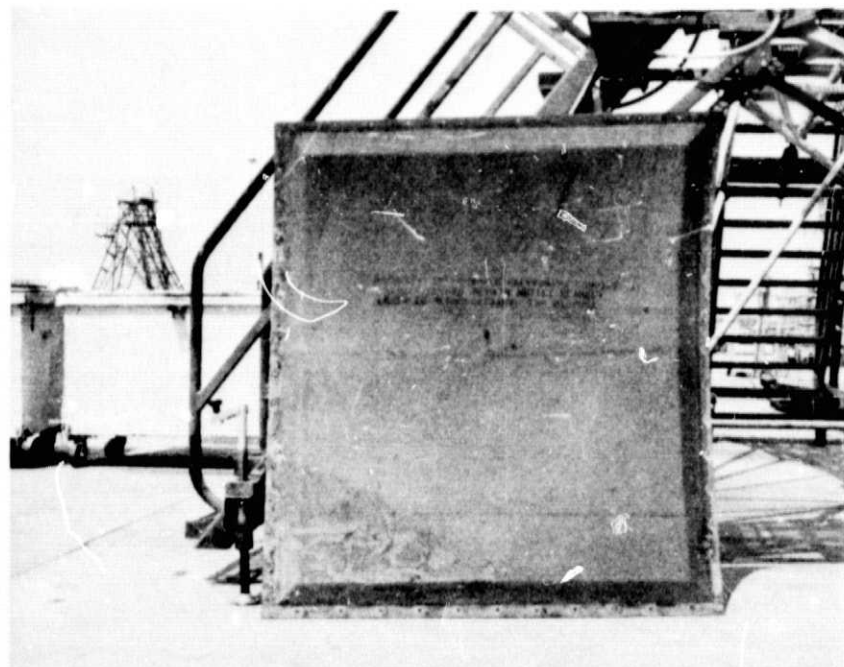
The inner face of the panel had an oily film on the upper edge and heavy oily patches on the aft edge as shown in Figure 4. The nature of the oil is not certain. It did not have the characteristic pungent odor of hydraulic oil, but the panels have potential exposure to phosphate ester fluid because of hydraulic lines located above the panels.

Figure 4. - Eastern LH Wing-Body Fairing -
Inner surface

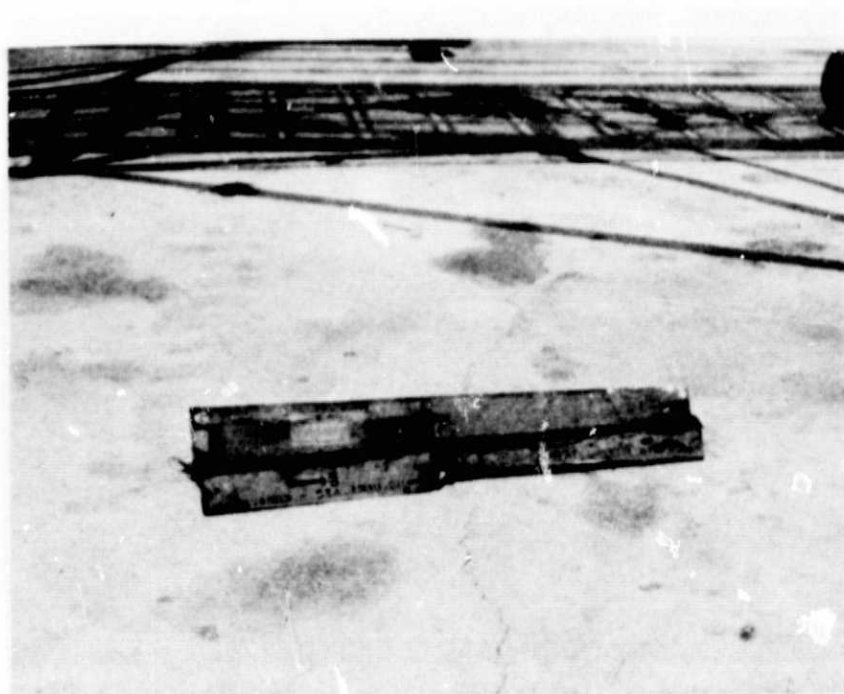
Upon removal of this fillet, considerable grime and black deposits were noted on the inner surface as shown in Figure 5. There was an oily residue on the inner surface; apparently it was not phosphate ester fluid since no

Figure 5. - Eastern LH Wing-Body Fillet -
Inner surface

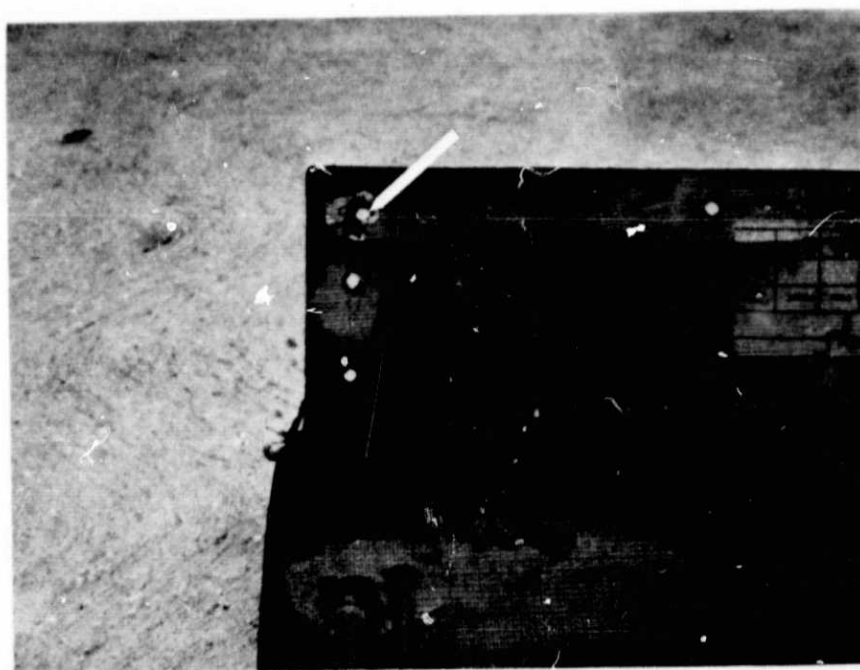
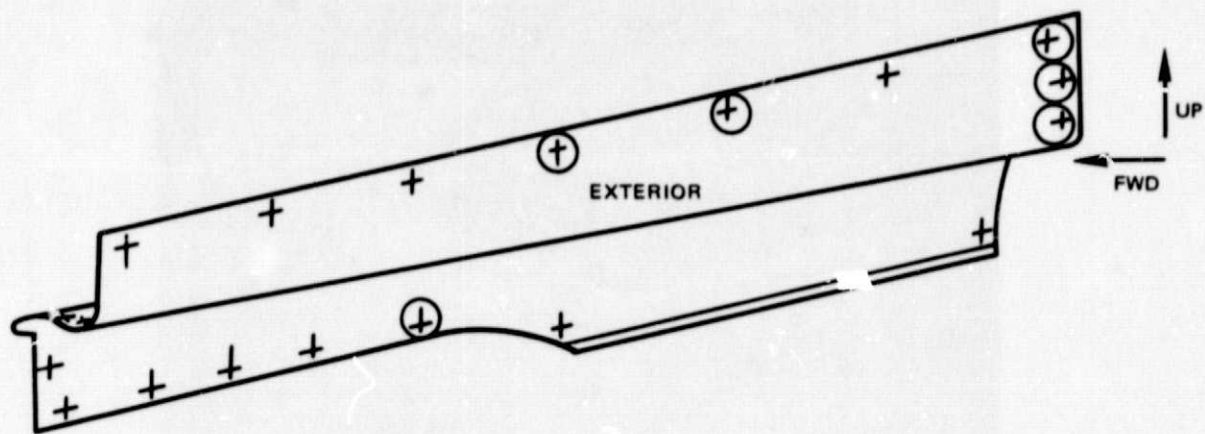
pungent odor was noticed. A gouged spot was noted on the upper forward corner, and paint and flame sprayed aluminum were missing in several locations on the exterior surface. Several elongated and frayed holes were observed as shown in Figures 6 and 7.

Figure 6. - Eastern LH Wing-Body Fillet -
Elongated holes

Figure 7. - Eastern LH Wing-Body Fillet -
Location of elongated holes

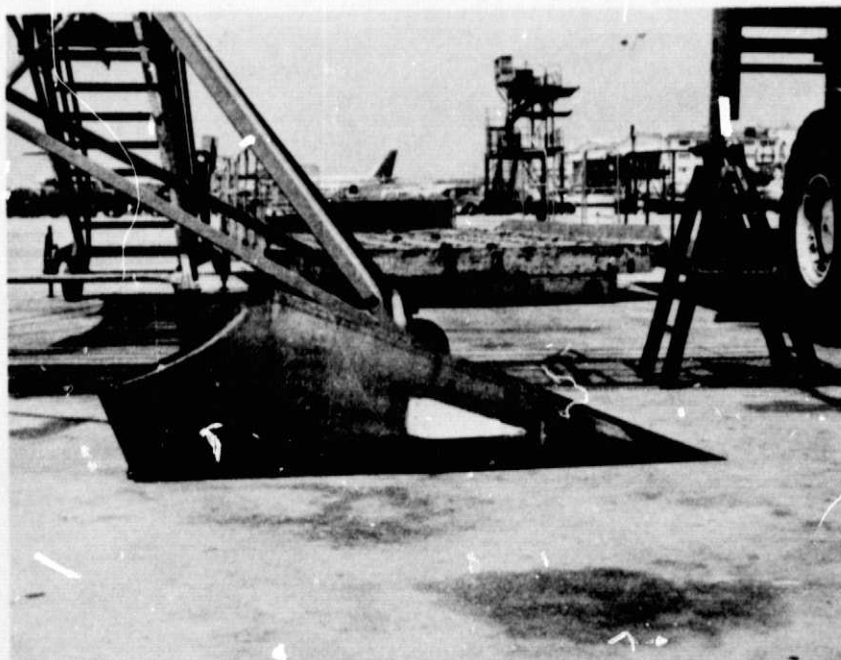
The inner surface of this panel, particularly the aft end, contained a considerable amount of oil, as shown in Figure 8. The oily residue did not appear to be hydraulic fluid. The outer surface of the panel was extremely dirty with a streaked appearance as shown in Figure 9. Several holes along the laminate edge were frayed with approximately 1/4 inch diameter delaminations around the holes (Figures 10 and 11). It should be noted that the fraying and delaminations are observable only from the inside of the panel. There was no evidence of additional defects in the panel.

Figure 8. - Eastern LH Aft Engine Fairing -
Inner surface

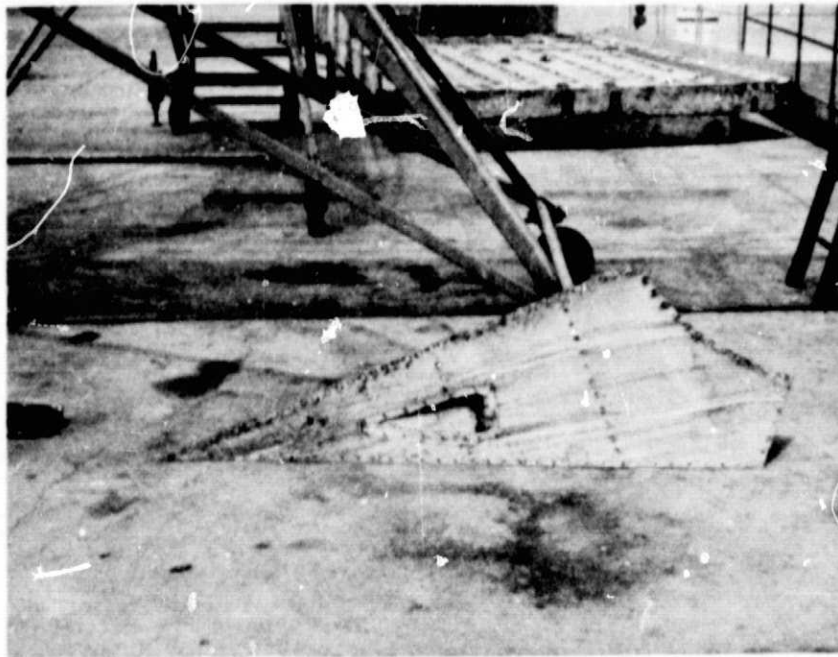
Figure 9. - Eastern LH Aft Engine Fairing -
Exterior surface

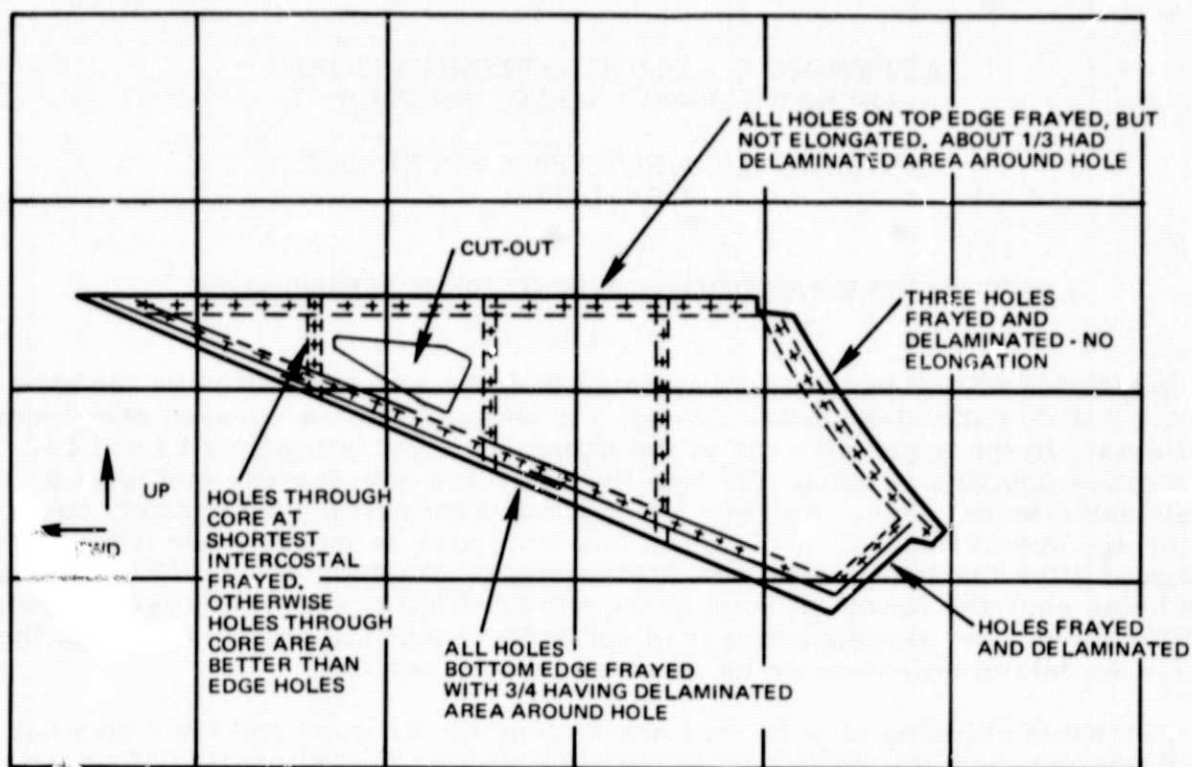
Figure 11. - Eastern LH Aft Engine Fairing - Location of fastener hole defects

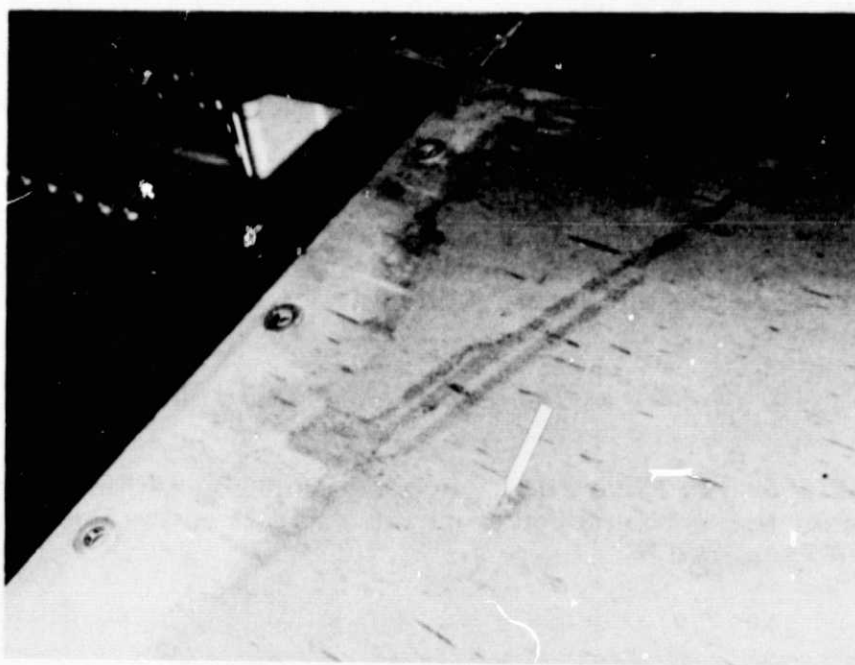
The right-hand panels were not removed, therefore, a visual inspection of the outer surface only was conducted. Two cracks 5/16 inch long and 1/8 inch long were noted in the outer skin as shown in Figure 12. The origin of these cracks is not known. The general appearance of the entire outer surface is similar to that of the left-hand wing-body fairing.

Figure 12. - Eastern RH Wing-Body Fairing - showing crack on exterior skin

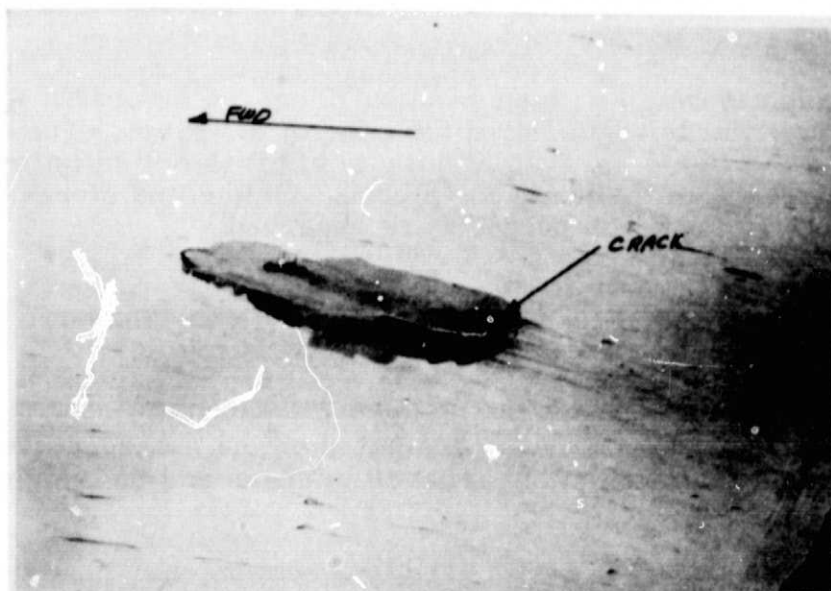
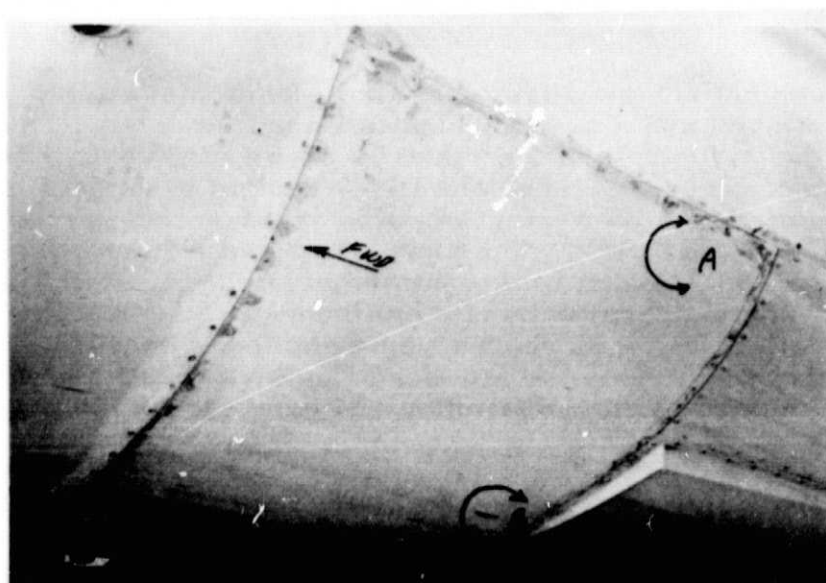
Inspection of this panel was conducted with the panel installed on the aircraft. A 1-1/4 inch long crack through the paint and flame sprayed aluminum still exists in the upper aft area of the panel as shown in Figures 13 and 14. This crack appears to extend through the skin, and coin tapping indicates a small delaminated area. An indentation around the crack was probably caused by foreign object impact. This crack has not grown in length since it was first reported after the 1974 inspection, Reference 2. Another crack 1/2 inch long was noted near the lower aft edge of the panel. This crack is through the paint and flame sprayed aluminum but it is not definite that the crack is through the skin. No delaminations could be detected by coin tapping.

Extensive chipping of paint was noted along the forward and top edges but the flame sprayed aluminum was intact. There was a light coating of grime over the exterior surface and black streaks probably caused by rubber particles were noted primarily near the bottom of the panel as shown in Figure 14. A thin oily film which did not appear to be hydraulic fluid was noted around fasteners and the panel edges. Also, minor damage areas were noted in the aft upper and lower corners. (Figure 14)

Figure 13. - Air Canada LH Wing-Body Fairing -
Exterior surface crack

Figure 14. - Air Canada LH Wing-Body Fairing -
Exterior

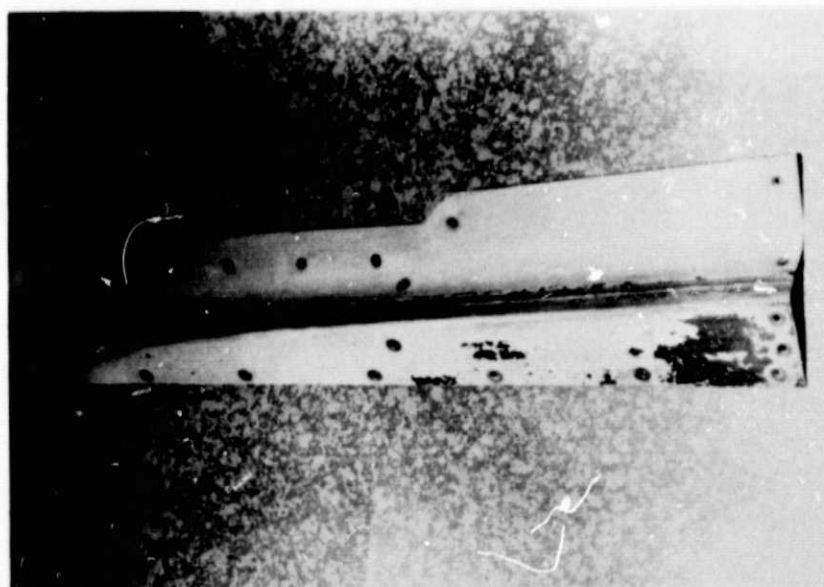
This panel was removed from the aircraft for detailed inspection. Considerable grime and an oily residue were noted on the external surface as shown in Figure 16. Paint chipping around fasteners and on the upper surface was noted.

Figure 16. - Air Canada RH Wing-Body Fillet -
Exterior

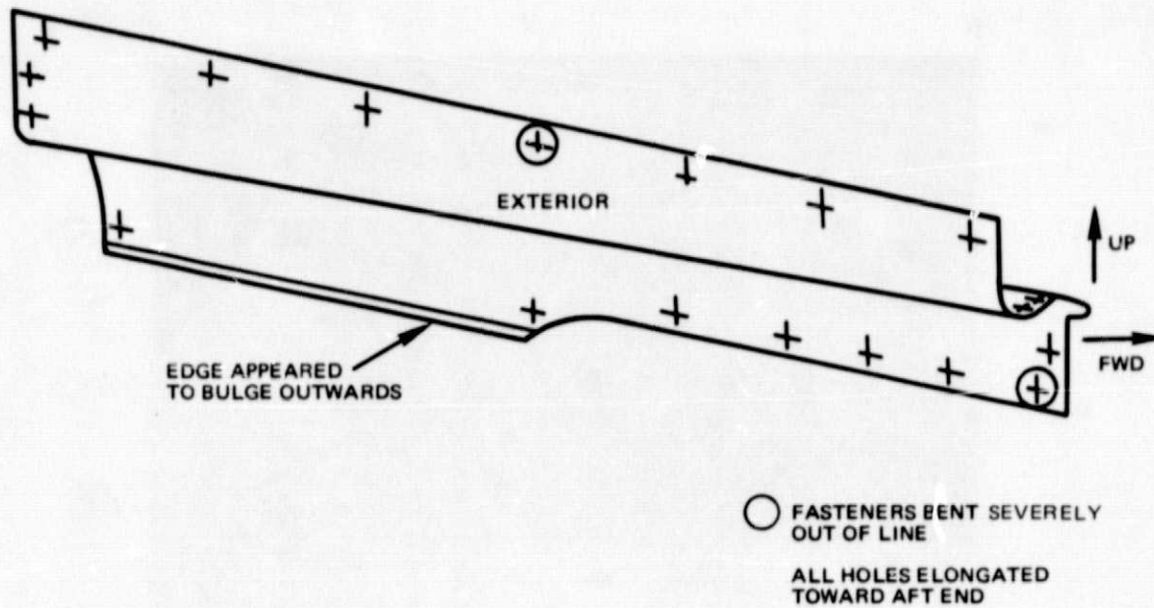
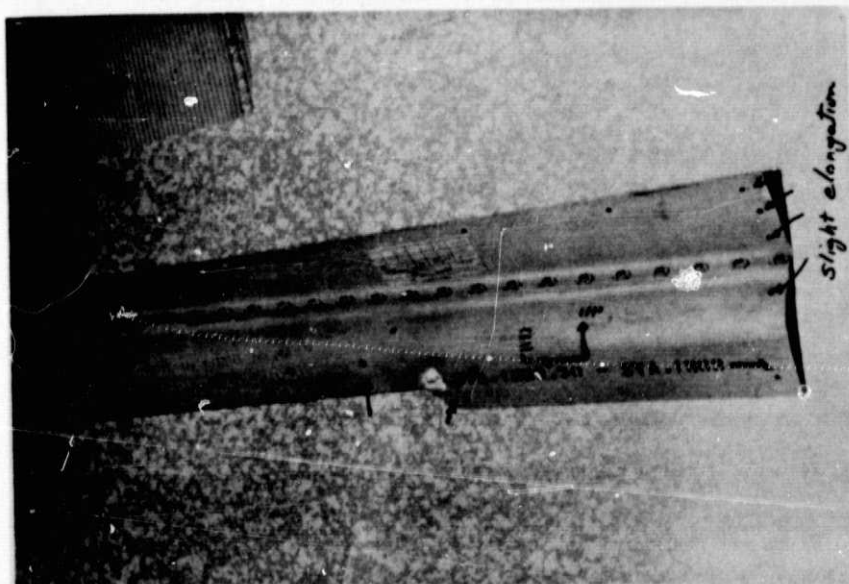
Bent or out of line fasteners with gaps between fastener heads and panel were noted as indicated in Figure 17. Also, the lower aft edge of the panel appeared to be bulged outward slightly. Indications are that this panel was forced to fit the aircraft fastener hole pattern. Elongation of fastener holes along the aft end of the panel was noted as shown on the interior view of Figure 18.

Figure 17. - Air Canada RH Wing-Body Fillet -
Location of defect areas

Figure 18. - Air Canada RH Wing-Body Fillet -
Inner surface

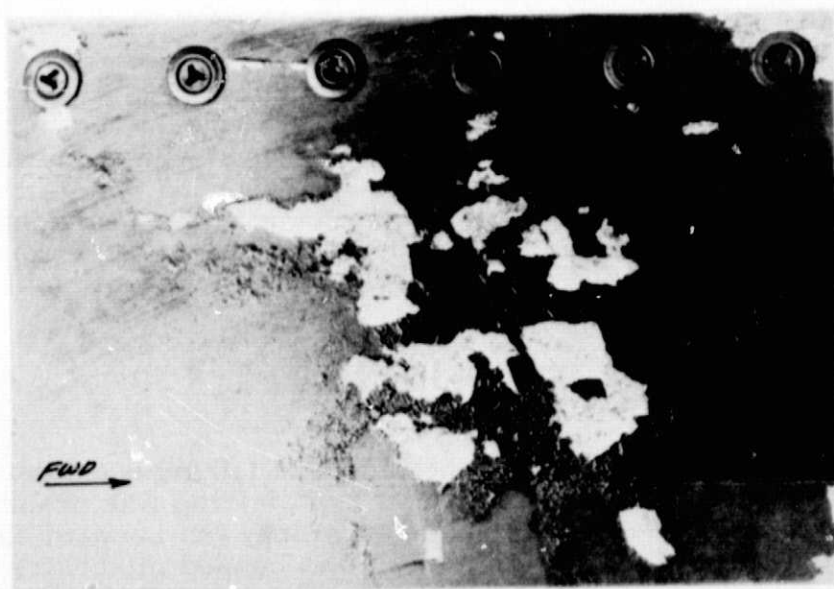
This panel was not removed from the aircraft for inspection. Considerable blistering of paint and a corroded appearance was noted. There was some evidence of pitting on the external surface as shown in Figures 19 and 20. The pitting and the corroded appearance are likely related to damage of the flame sprayed aluminum. Paint blistering was also noted on this part at the first annual inspection, Reference 2. The loose paint was removed from the fairing after the first inspection and it was repainted prior to reinstallation. The paint adhesion problem, possibly related to inadequate removal of mold release after part fabrication, has thus reoccurred within one years time. In view of the absence of this problem on the left-hand Kevlar fairing, the paint adhesion does not appear related to the substitution of Kevlar-49 for fiberglass.

Figure 19. - Air Canada RH Aft Engine Fairing - Exterior

Figure 20. - Air Canada RH Aft Engine Fairing - Blistered paint

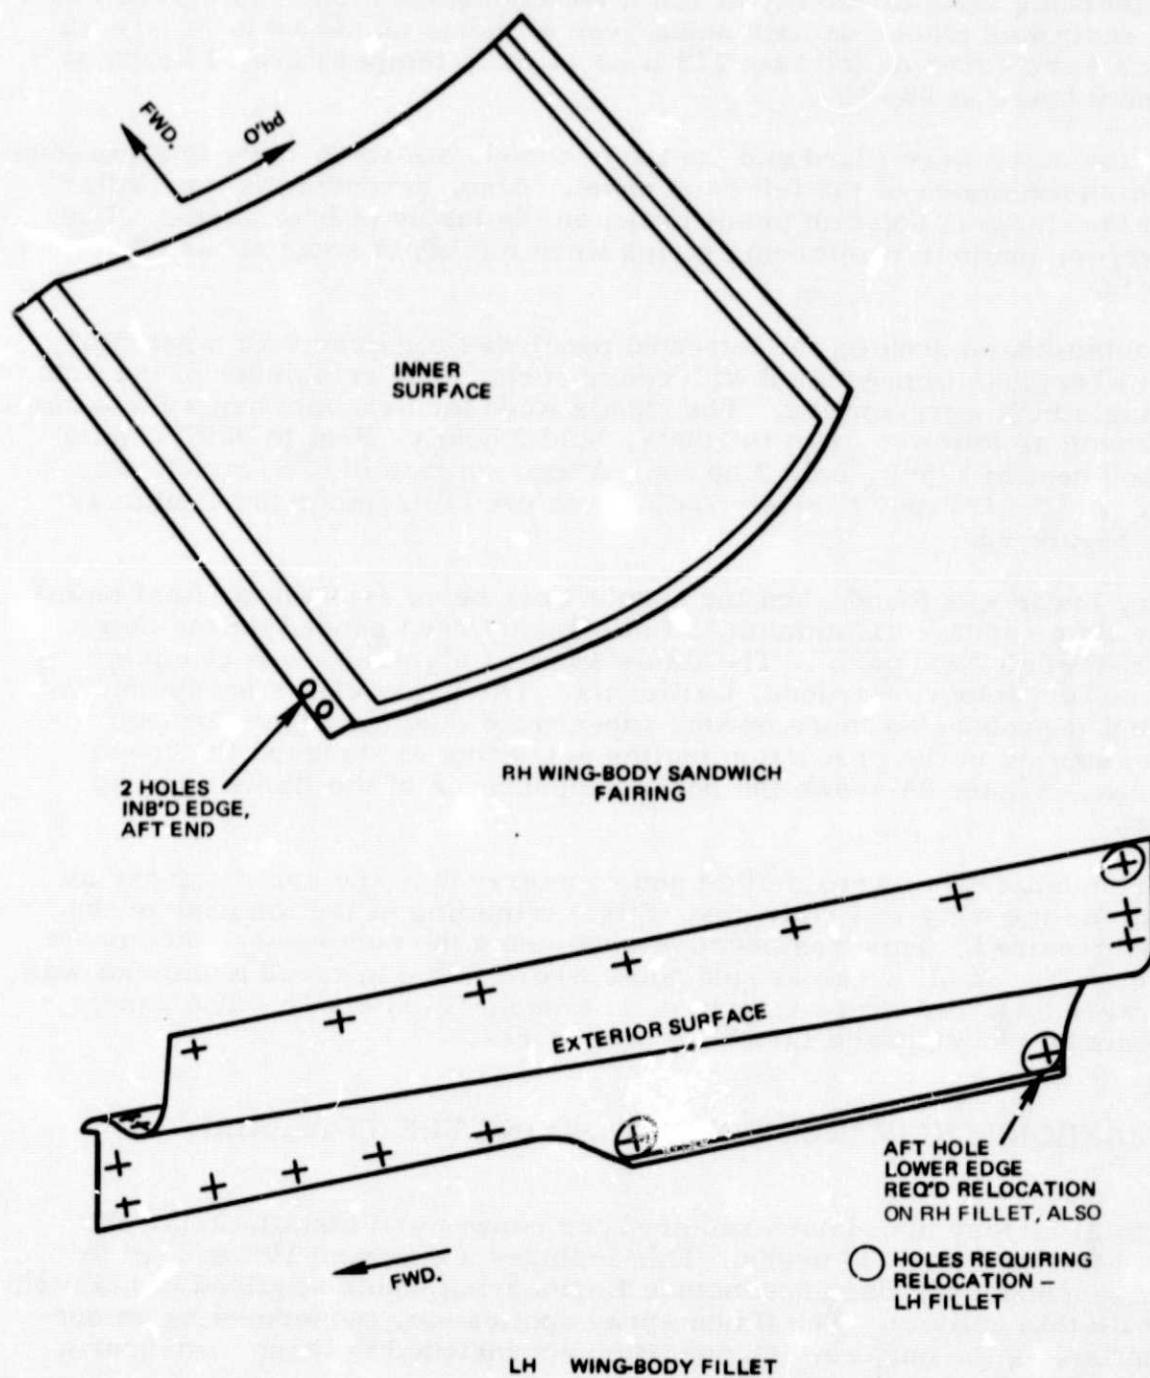
Figure 21. - TWA Under-Wing Panels
Location of holes requiring filling

A total of six holes required relocation prior to installation of the panels. All the holes were in solid laminate areas and Figure 21 shows hole locations for the right hand wing-body fairing and the left hand wing-body fillet. The holes were filled with an epoxy resin filled with chopped glass fibers and cured for 4 hours at 135° F. The holes were drilled and countersunk using special tools and procedures detailed in Reference 1. All parts were solvent cleaned and repaired according to standard L-1011 finish specifications.

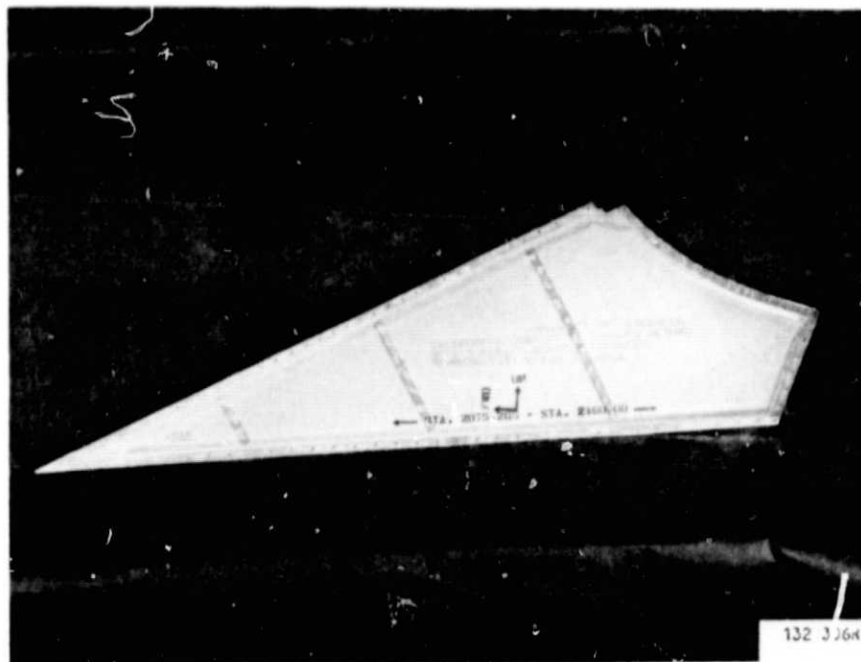
Figure 22. - TWA Aft Engine Fairing -
Inner surface showing fastener
reinforcing strips (before finishing)

A reinforcing strip of one ply of 120 style fiberglass cloth impregnated with an epoxy resin was placed on both skins over all holes as shown in Figure 22. The resins were cured as follows: 1/2 hour at room temperature, 3 hours at 180°F and 2 hours at 335°F.

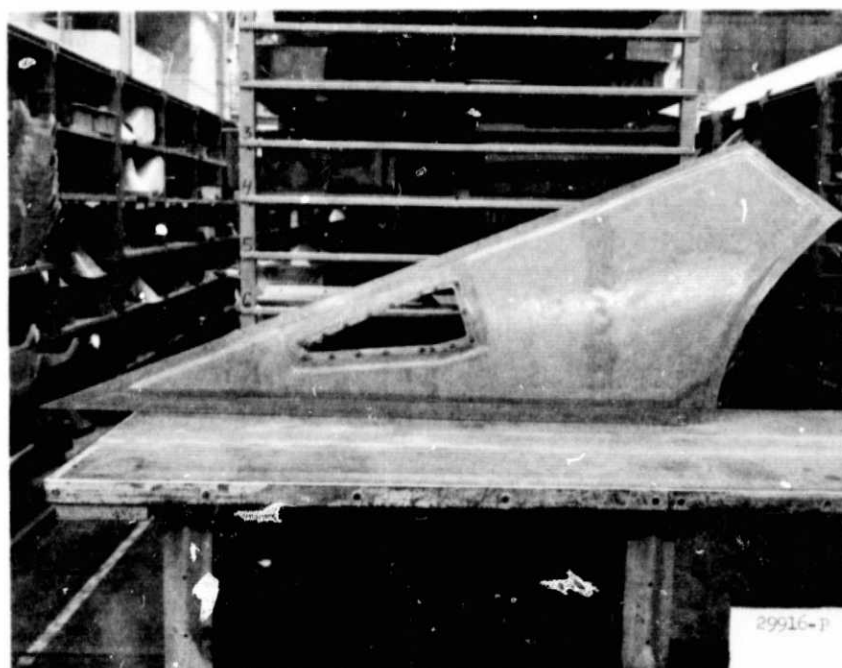
After the holes were filled and the resin cured, a skin-to-core delamination was noted on the inside of the left hand panel. Also, debonding of the Tedlar moisture barrier was noted in small areas on the inside of both panels. Due to shop error, the hole reinforcing strips were left off in some areas of both panels.

Figure 23. - TWA L/H Aft Engine Fairing -
Vapor barrier coating

The delaminated area on the left hand panel was repaired with a patch of 120 style fiberglass impregnated with epoxy resin. The remainder of the hole reinforcing strips were applied. The panels were then vacuum bagged and cured under vacuum as follows: Heat to 190°F, hold 2 hours; Heat to 300°F, hold 1 hour; and heat to 335°F, hold 2 hours. A heat-up rate of 5°F/minute was followed. A 10 mil vapor barrier coating was used to replace the Tedlar as shown in Figure 23.

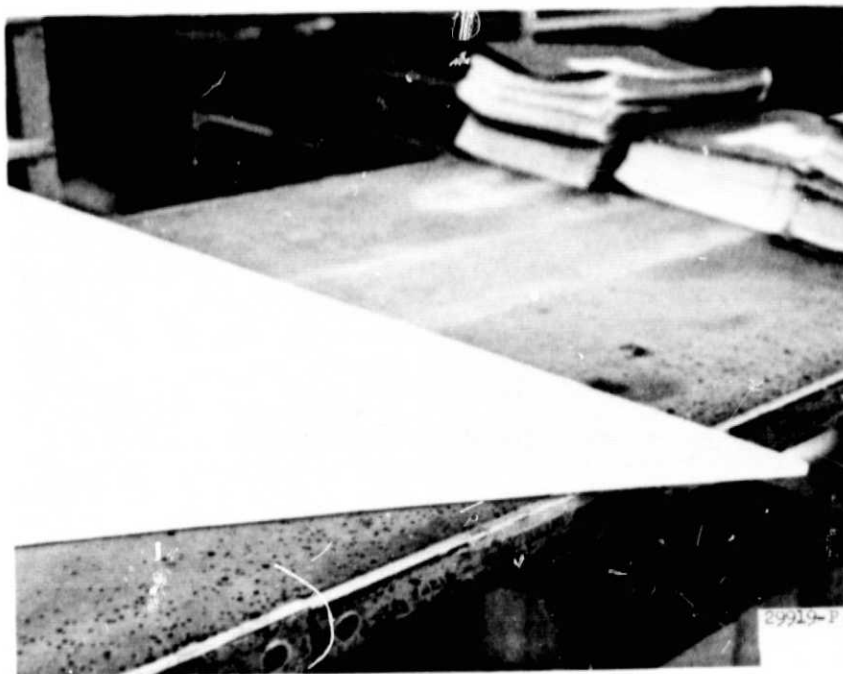
Figure 24. - TWA Aft Engine Fairing
After re-application of Flame Spray

A shop error was found when the panels were being readied for final painting. The flame sprayed aluminum had mistakenly been sanded off the outer surface of the left hand panel. The flame sprayed aluminum was reapplied by Plasma Technology, Gardena, California. Their process is acceptable for repair, but it produces a more porous appearance than the flame sprayed aluminum applied in the production tooling according to standard Lockheed Procedures. Figure 24 shows the porous appearance of the flame sprayed aluminum.
